**Subject: Sanctuary Youth Shelter  
Limited Asbestos Inspection for Renovation Purposes**

**ASBESTOS SURVEY FOR RENOVATION PURPOSES**  
**Sanctuary Youth Shelter - Main Building**  
**HMS Project No. F13216**

**ASBESTOS SURVEY FOR RENOVATION PURPOSES**  
**Sanctuary Youth Shelter - Detached Conference Building**  
**HMS Project No. F13216**  
**Inspection Date: October 4, 2013 Report Date: October 8, 2013**

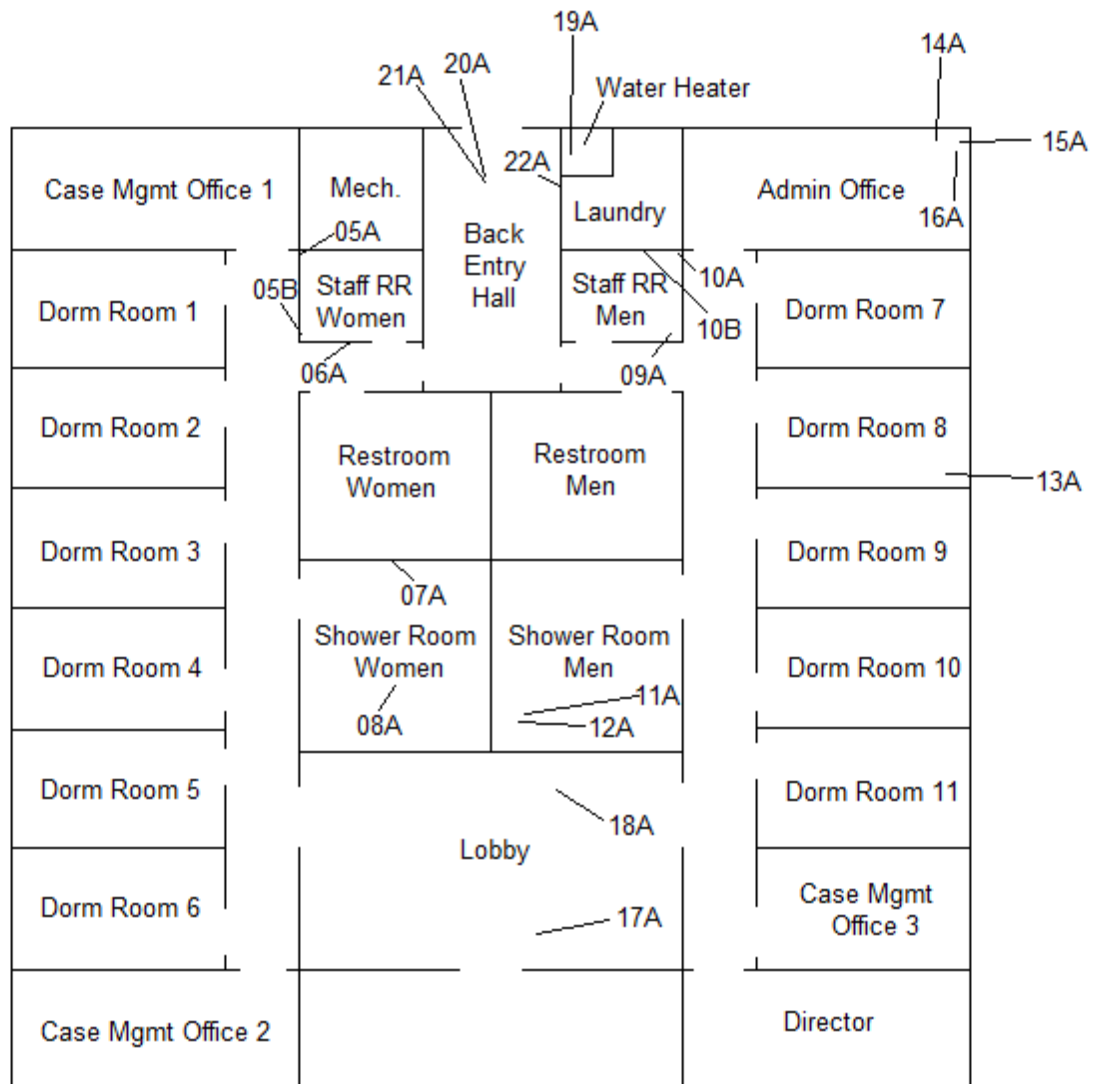
1545 N Street, Fresno, CA

Representative bulk samples of suspect materials were collected using a knife, scraper, chisel, or power drill. Sample locations are indicated on the building sketches and chain of custody forms included with this report. The samples were analyzed using polarized light microscopy (PLM) by Forensic Analytical Laboratories, Inc. in Hayward, CA.
